PG Water Consumption Monitoring and Savings System

FINAL REPORT

Innovative Conservation Program

2018 ICP – Agreement No. 181288

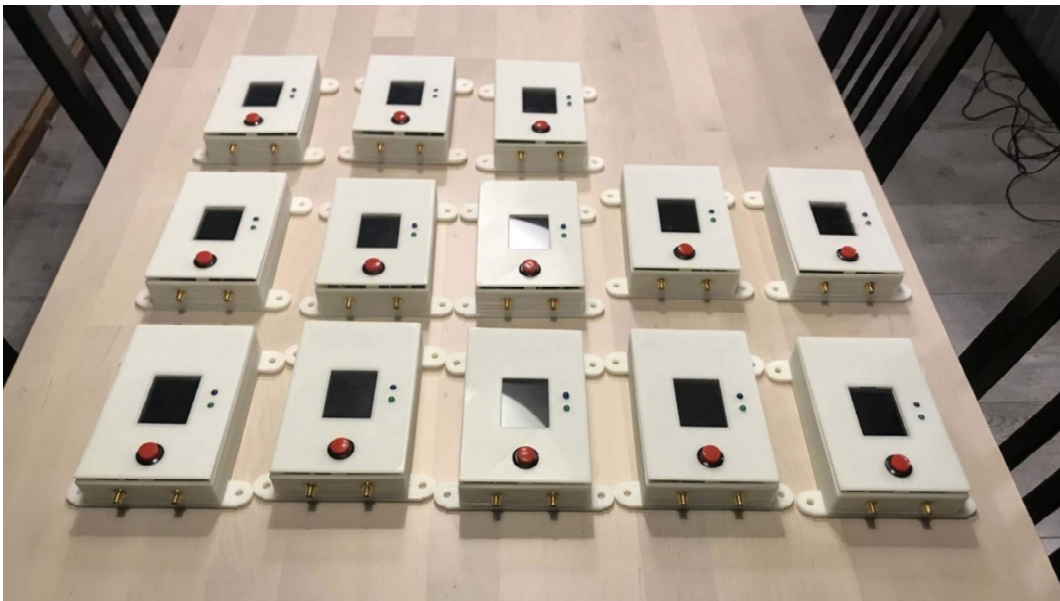
Device Manufacture

A batch of **16 electronic devices** were manufactured specifically for the study; parts were procured from China and then assembled and tested. **12** devices were used "in the field"; **2** served as "**backups**" and were eventually cannibalized for spare parts; and **2** were used in a **technical support** capacity for prototyping hardware fixes, software debugging, and regression testing.

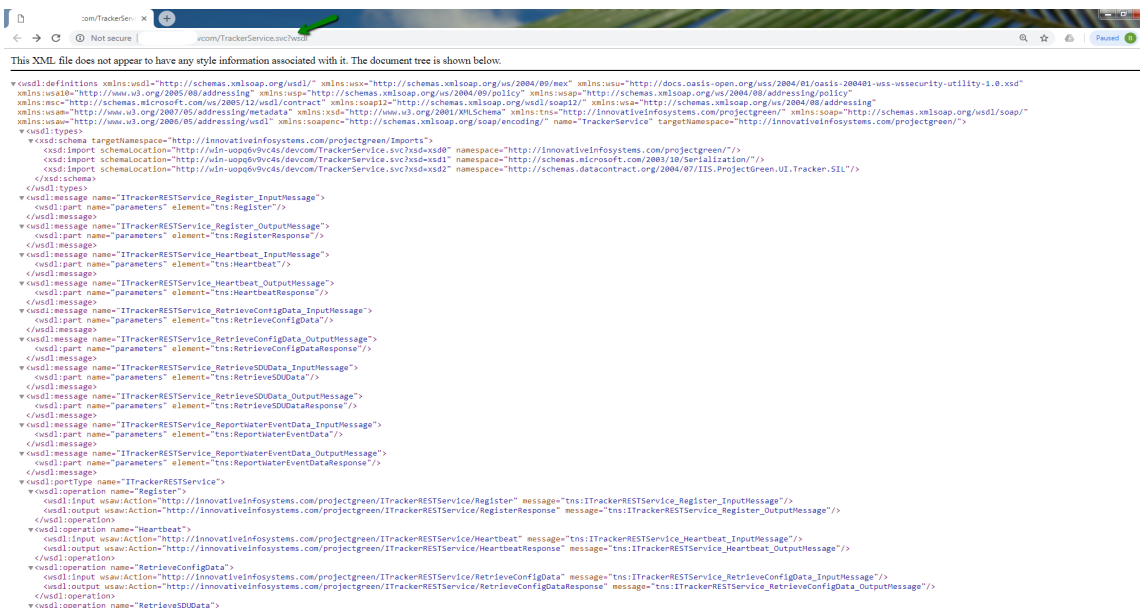
The screenshot shows an XML file named 'vcom/TrackerService.svc?xsd'. The XML defines the schema for the TrackerService. It includes definitions for the schema, the service, and the messages. The schema is defined by the 'xsd:schema' element. The service is defined by the 'wsdl:service' element. The messages are defined by the 'wsdl:message' element. The schema is defined by the 'xsd:schema' element. The service is defined by the 'wsdl:service' element. The messages are defined by the 'wsdl:message' element.

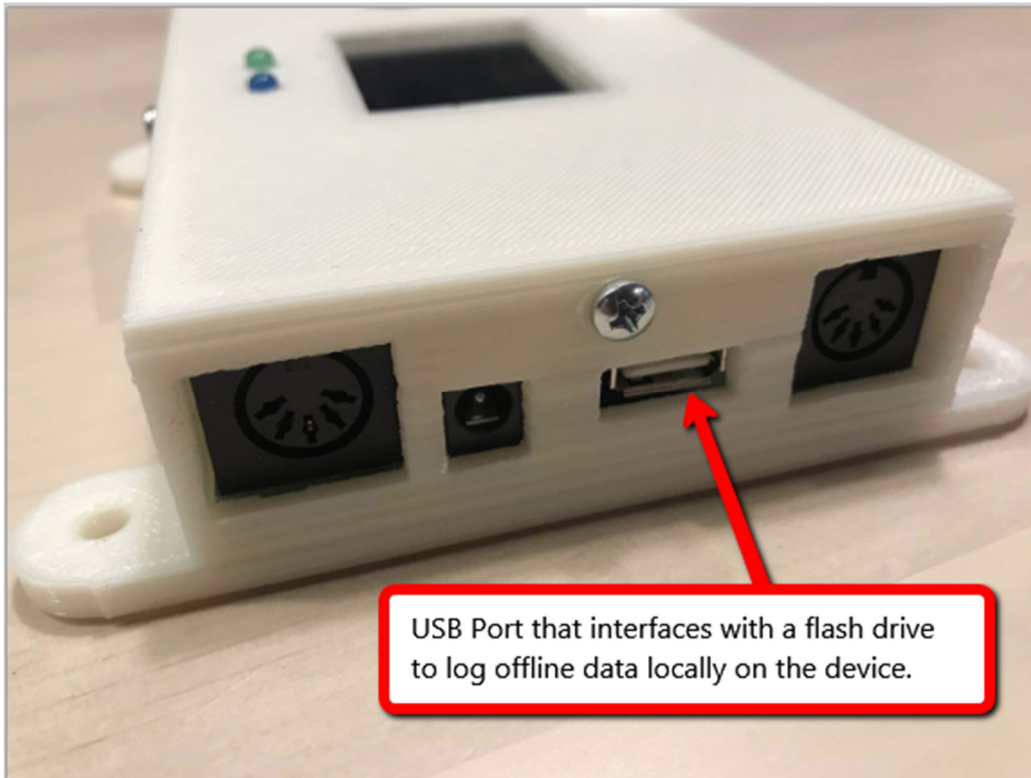
There's a USB drive built into the main board (shown in the screenshots appearing on the next page). When a Wifi connection is not present and a water event is sensed, the water event data is written to a flash drive that is plugged into the USB port, which saves the water event data so that it can be sent to the server once a connection is reestablished or once someone manually pulls the data off the flash drive.

Unfortunately, there was a bug in the firmware that caused the "write" operations to the flash drive to halt unexpectedly, preventing the device from storing water event data for events sensed while the device was offline. The writing of water events to the local flash drive was our fail-safe backup strategy for Wifi communication issues, but it also failed.

The firmware bug that caused the USB write operation failures was traced to an issue with the driver created by the part's manufacture, and was resolved by reaching out to the manufacturer to obtain a library file that contained the fix, which was eventually incorporated into a new version of the firmware and flashed to the devices.
